Technical Report GL-97-6 June 1997

## RFI Interim Measure, Geophysical Investigation, SWMU 02/11, Dye Burial Grounds, Naval Surface Warfare Center, Crane Division, Crane, Indiana

U.S. Army Corps of Engineers Waterways Experiment Station 3909 Halls Ferry Road Vicksburg, MS 39180-6199

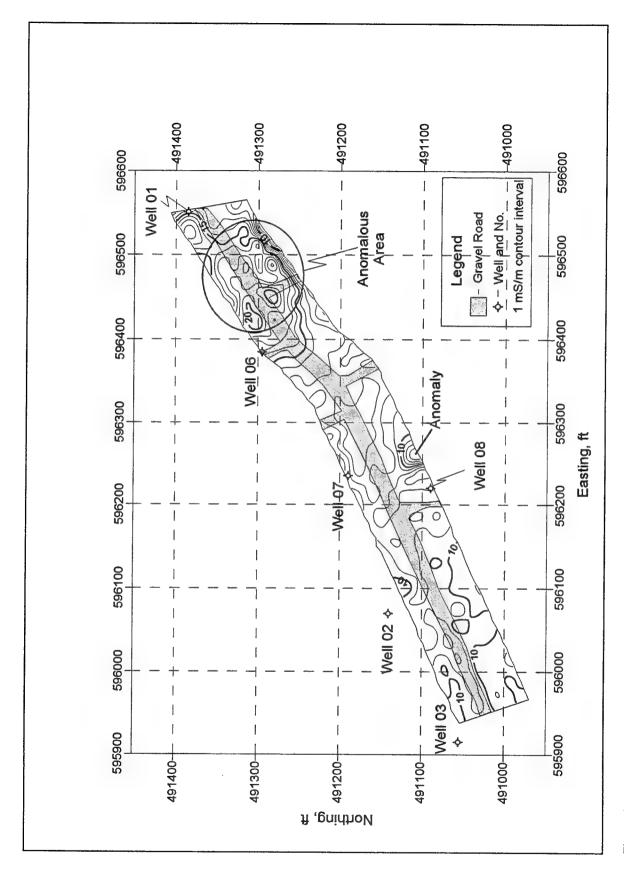
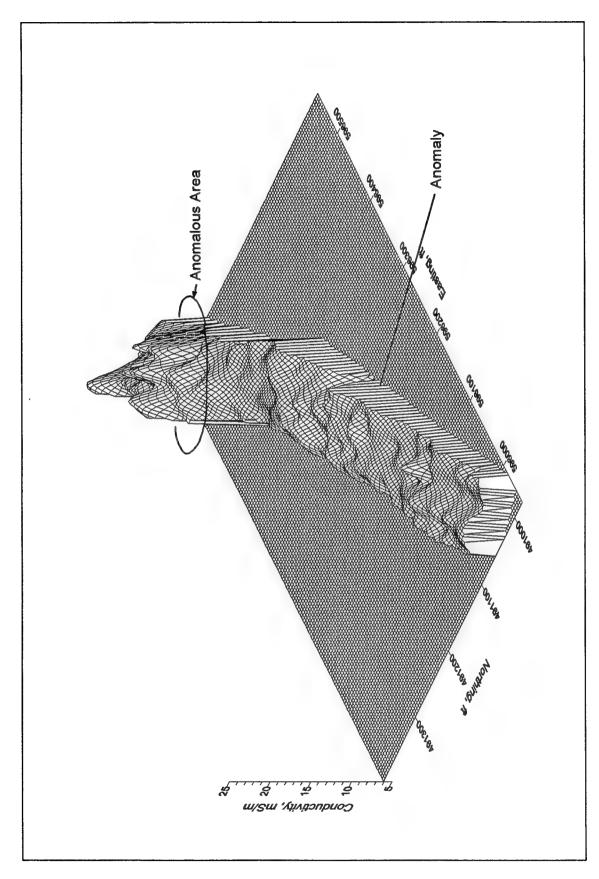
Figure 18. EM31 conductivity test results

The results of the EM31 conductivity survey are presented in Figures 17 through 19. Each data set is presented in profile, as a contour map (two dimensional view), and as a block diagram (three dimensional view). Figures 17 through 19 indicate that background conductivity values for the site range between 10 and 13 mS/m. Based on the range of the background values two anomalous zones can be distinguished in Figures 18 and 19.

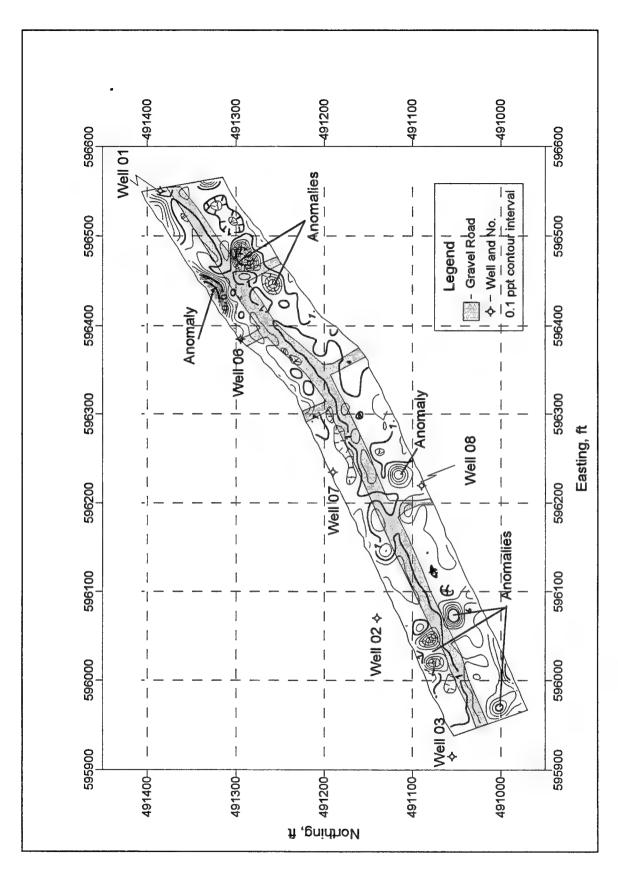
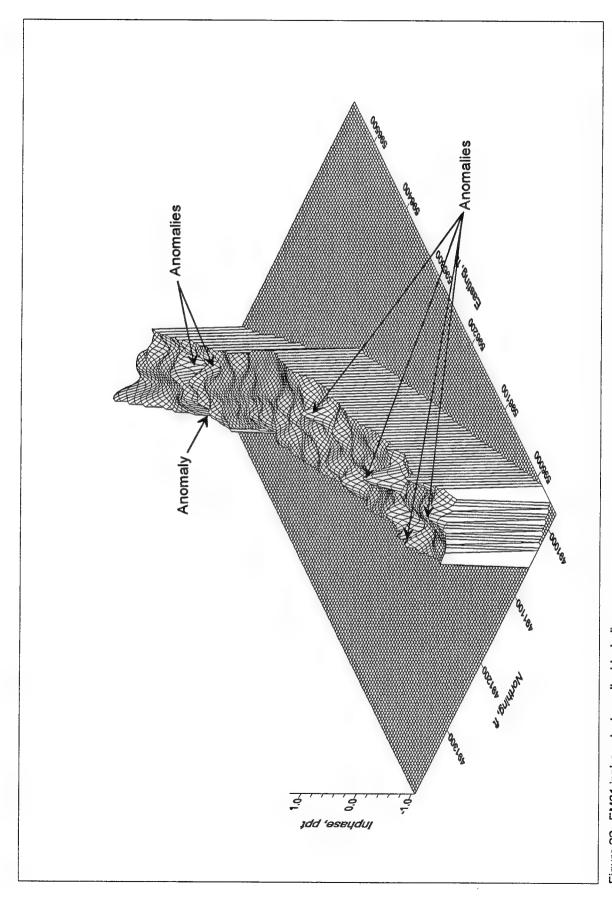
Figure 21. EM31 inphase test results

The EM31 inphase results are presented in Figures 20 through 22. The results indicate that background values for this area range between approximately 0.3 and 0.8 ppt. The data indicate several anomalously high and low value areas. High and low anomalous areas may be indicative of buried metallic objects. Five high-valued and three low-valued areas were detected and are noted in Figures 21 and 22.

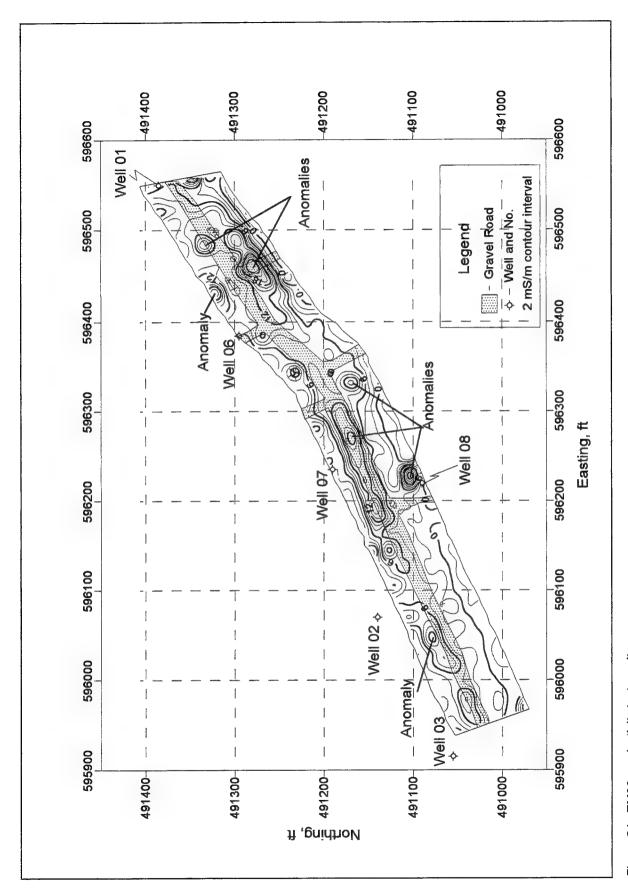
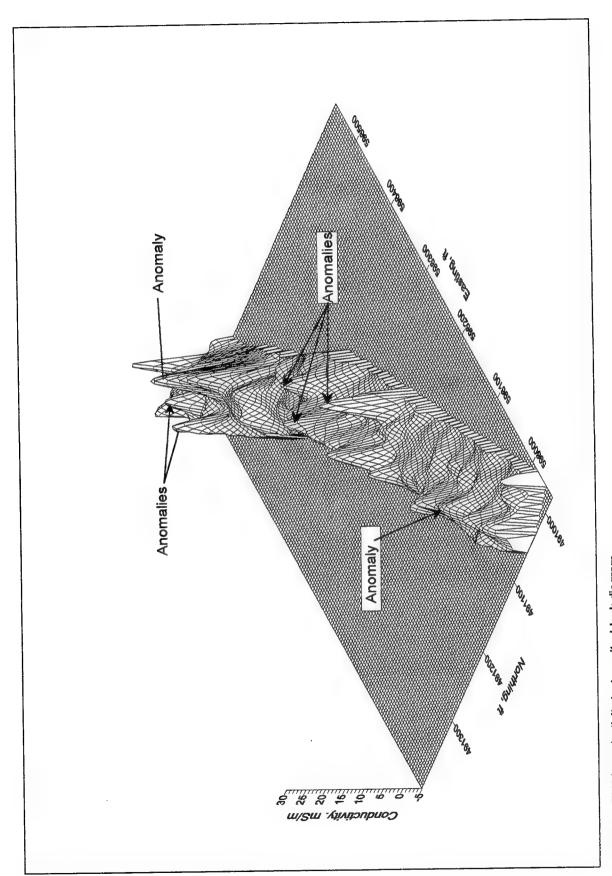
Figure 24. EM38 conductivity test results

Figures 23 through 25 present the results of the EM38 conductivity survey. Those areas having conductivity values in excess of 10 mS/m are considered to be anomalous and are accordingly noted in Figures 24 and 25.

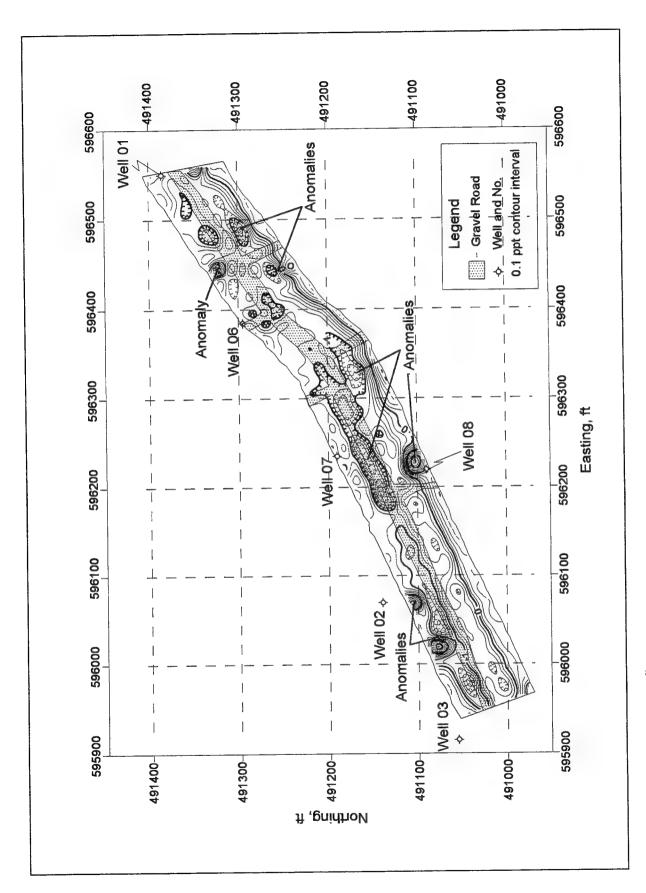
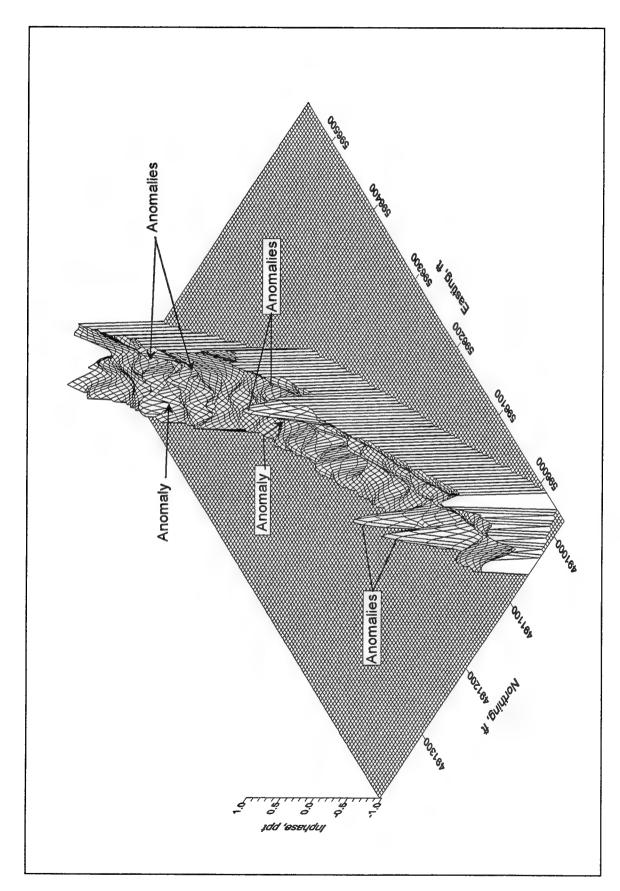
Figure 27. EM38 inphase test results

The results of the EM38 inphase survey are shown in Figures 26 through 28. Values greater than 0.5 and less than -0.8 ppt were regarded as anomalous are indicated in Figures 27 and 28.

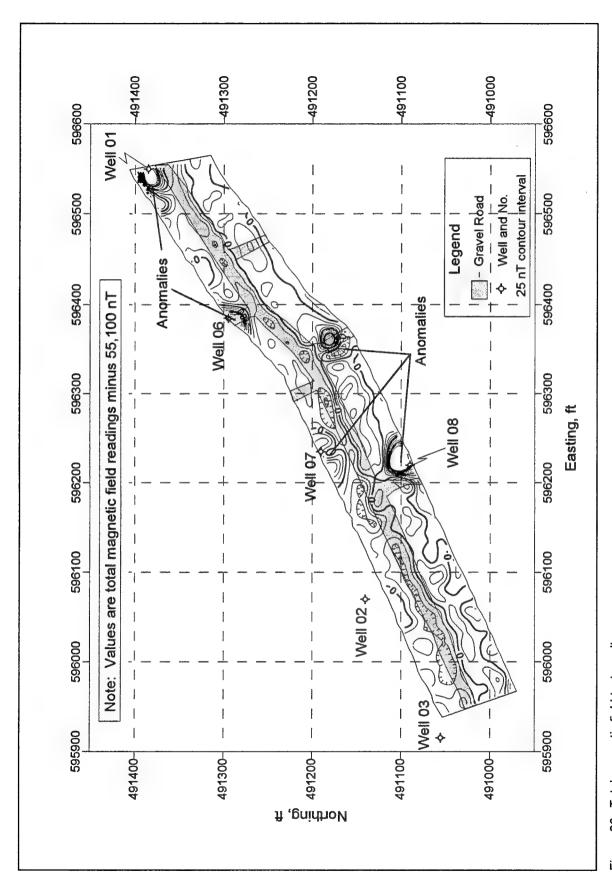
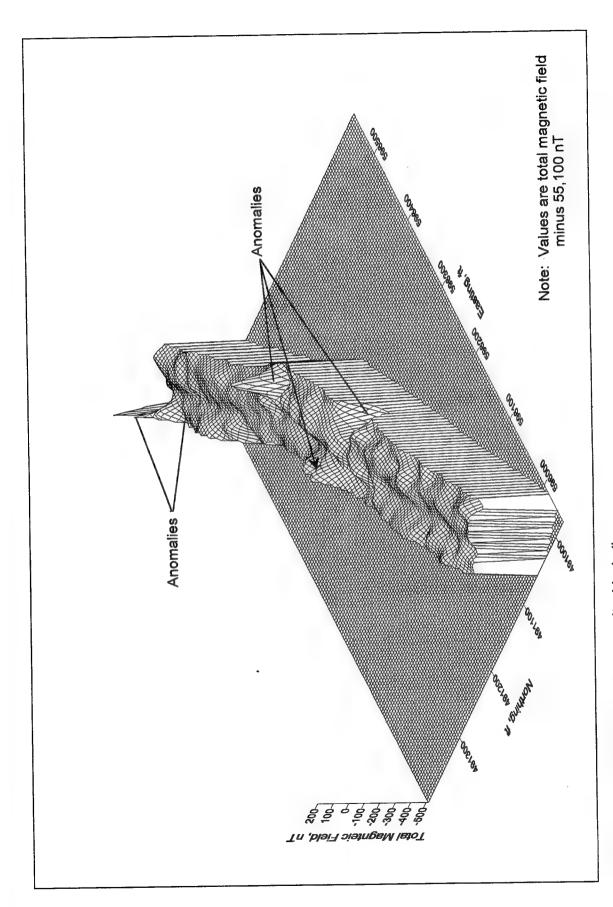
Figure 30. Total magnetic field test results

The total magnetic field survey results are shown in Figures 29 through 31. The data presented in Figures 30 and 31 show a nominal value of 55,100 nT, the regional field, subtracted from the measured field. Five anomalous areas are distinguished in Figures 30 and 31. All of the anomalies shown in the figures correlate with the location of metal-cased observation wells with the exception of the anomaly located at (596350,491180).

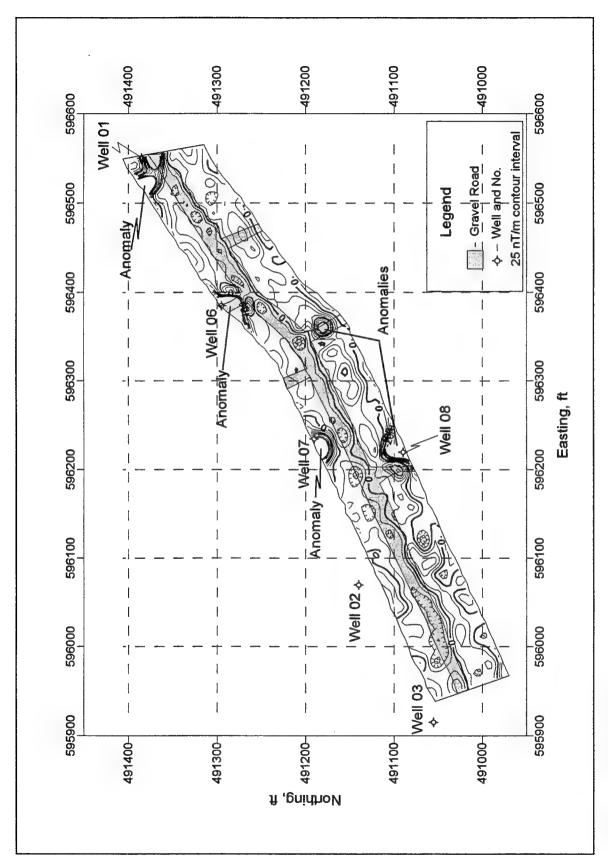
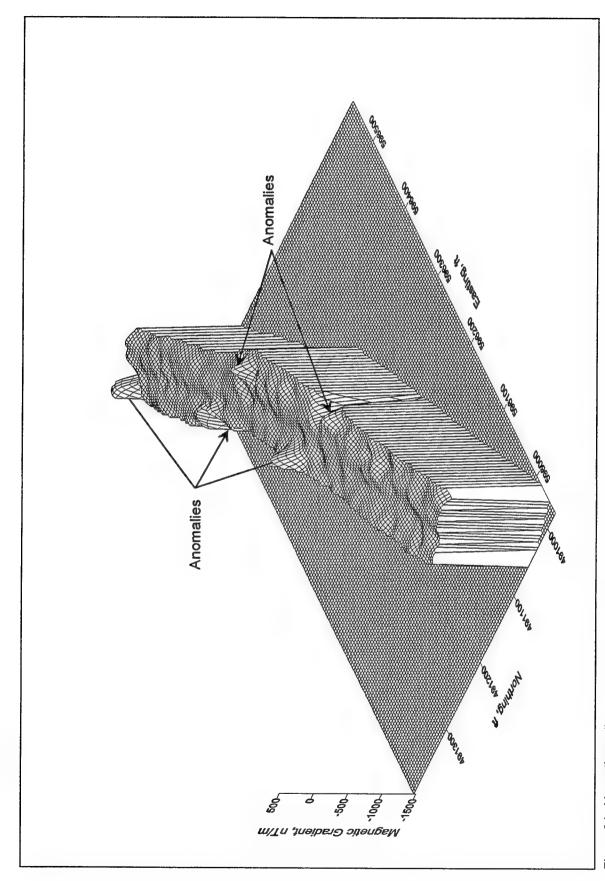
Figure 33. Magnetic gradient test results

The results of the magnetic gradient survey are presented in Figures 32 through 34. The locations of the anomalies interpreted from the survey are indicated in Figures 33 and 34 and the locations are identical to those for the total magnetic field survey.

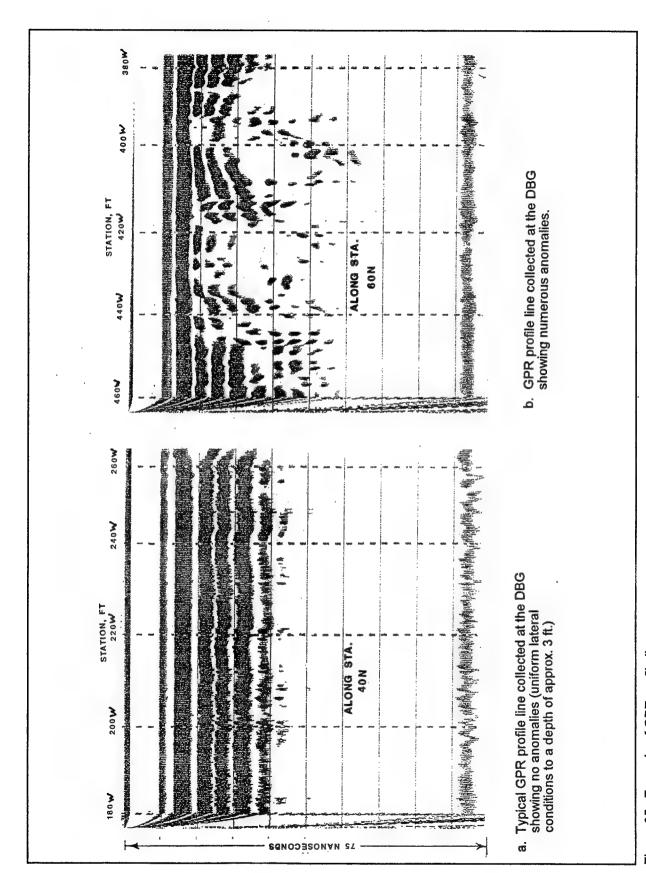
Figure 35. Example of GPR profile lines

Figure 35 shows examples of GPR profile lines collected at the site. Figure 35a shows no indications of any anomalies whereas Figure 35b shows numerous anomalous features. A total of 11 anomalous regions were identified with the GPR and their locations are shown in Figure 36. Three anomalies are small (less than 10 ft long) with the remaining eight ranging in size from 15 to 100 ft in length.

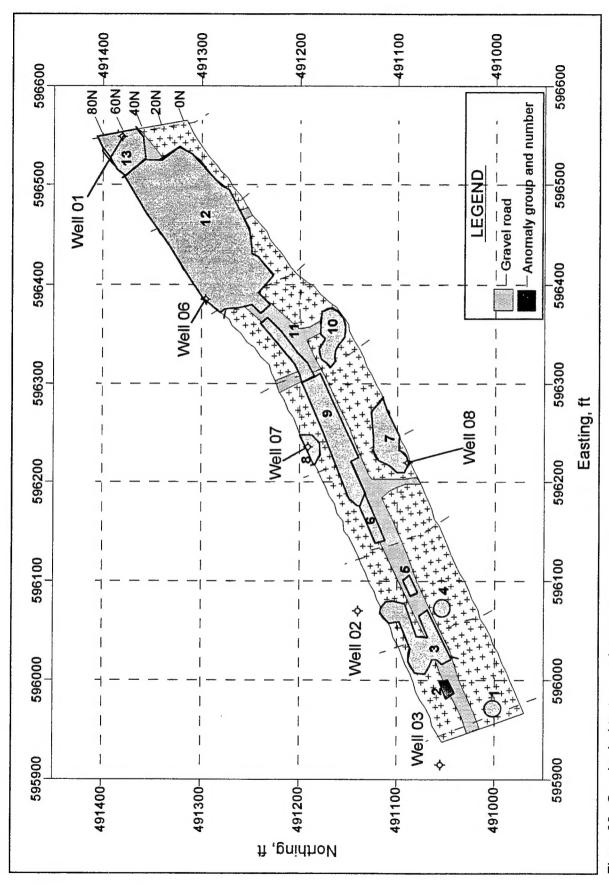
Figure 38. Geophysical test anomaly group map

To facilitate visualizing the results of the various surveys conducted at the site, an integrated anomaly map was prepared (Figure 37). This figure shows the anomaly type (magnetic, EM31 conductivity, GPR, etc.), anomaly location and its approximate areal extent. The individual anomalies shown in Figure 37 were gathered into anomaly groups as shown in Figure 38. The groups were located by outlining the areas with anomalous values shown in Figure 37. In some cases the groups contain anomalies identified from more that one test while other groups are based on anomalies from a single survey type. The 13 anomaly groups shown in Figure 38 are described in the table below.

Anomaly Group No.	EM31		EM38		Magn	Magnetics		
	Cond	IP	Cond	IP	TMF	Grad	GPR	Description
1		x						Small area, probably small metallic object.
2							х	Small target, probably shallow soil disturbance.
3		х	X	х			x	Possible burial trenches with small metallic objects.
4		х						Possible small metalli objects.
5							х	Possible disturbed so and small metallic objects.
6							х	Possible soil disturbance (trench?)
7	X	x	x	x	x	x		Probably a small buried metallic object. TMF and Grad anomalies may be caused by nearby metal casing.
8					х	х		Anomaly probably caused by nearby steel well casing.
9			X	х			X	Disturbed soil with high conductivity (trenches?), possible small metallic objects.
10			х	х	х	х		Probably a small, shallow metallic object.
11							x	Disturbed soil layering (trench?), possible metallic object at approximately (596330,491210)

Anomaly Group No.	EM31		EM38		Magnetics			
	Cond	IP.	Cond	ΙP	TMF	Grad	GPR	Description
12	X	X	X	×	X	×	X	TMF and Grad anomalies probably caused by nearby steel well casing. EM31 Cond is relatively high in this area. This may be caused by a change in geology (i.e. shale is shallower) or an increase in clay or water content, metallic objects, or ground water conductivity (pollution plume?). The EM31 IP anomalies probably caused by metallic objects. The EM38 Cond anomaly may be caused by an increase in clay or water content. The various GPR anomalies in this area indicate that the disturbed area may be caused by trenching operations.
13					х	х		Anomaly caused by nearby steel well casing.

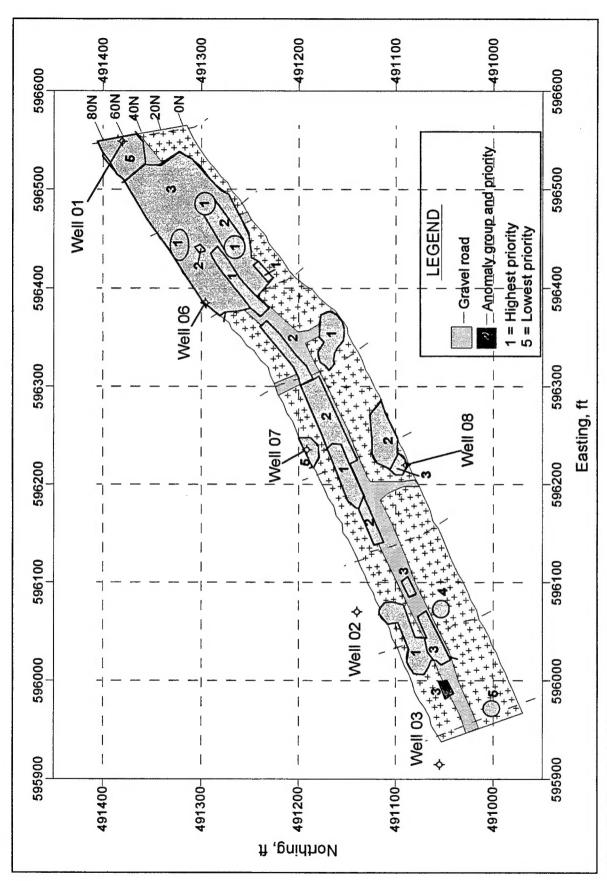
Figure 39. Geophysical test anomaly priority map

The geophysical anomalies interpreted above are used to construct a map showing the priority of areas to be further investigated (Figure 39). The priority values shown in Figure 39 range between 1 (highest priority) and 5 (lowest priority). The priority values on the map are based on the number, kind, and size of the anomalies interpreted from the geophysical surveys.

A geophysical investigation consisting of EM, magnetic, and GPR surveys was conducted at NSWCCD to delineate zones suspected of being used for the burial of various waste materials. Several of the areas surveyed are interpreted as having anomalous readings and are noted. The interpreted anomalous areas may be caused by soil disturbance caused by trenching activities or materials contained within them. It is recommended that the anomaly priority map be used as a referrence when considering which and in what order anonmalous areas should be further investigated.
